## PIPELINE INVESTIGATION REPORT

P01H0004

### CRUDE OIL PIPELINE RUPTURE

ENBRIDGE PIPELINES INC.

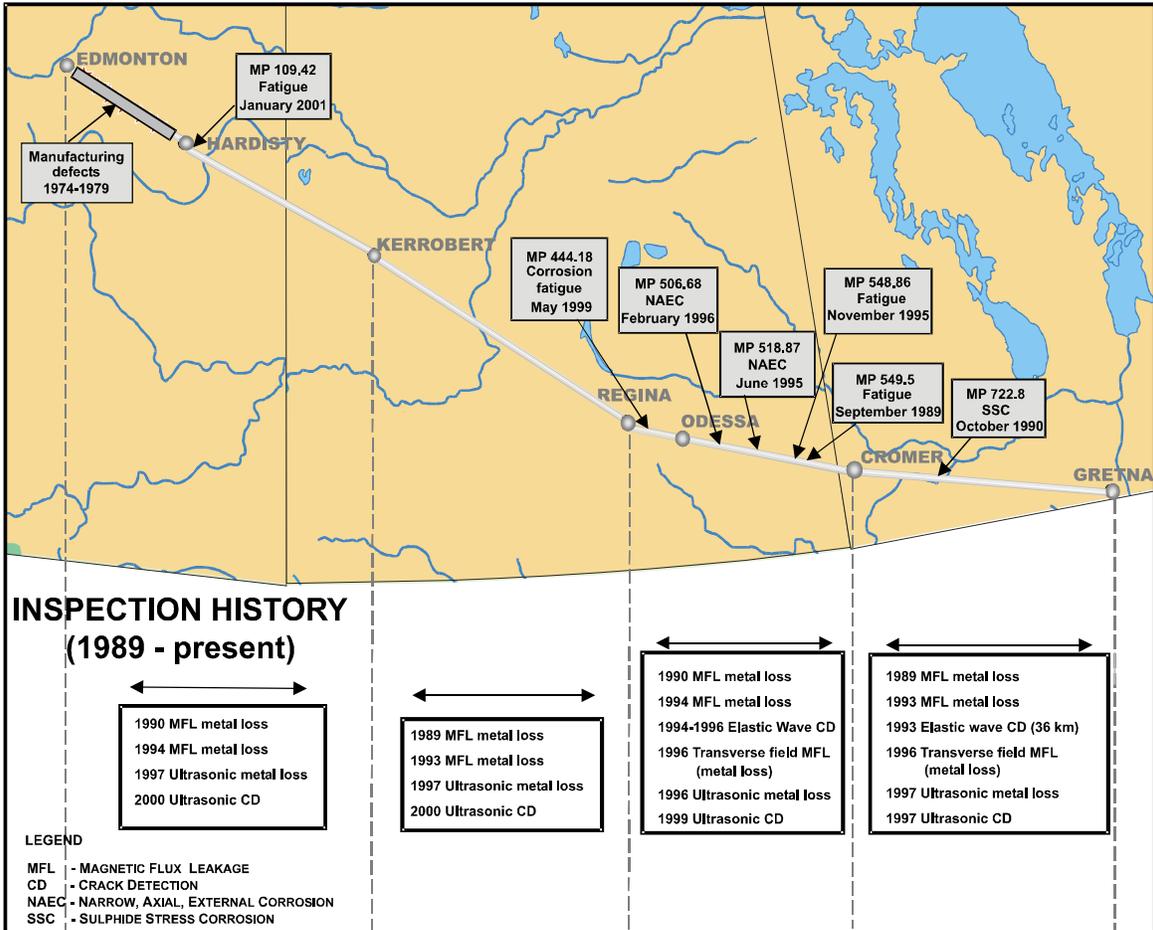
# Appendix A – Long Seam Failures on Line 3/4 (864 mm)

The following long seam-related failures have occurred on the 864 mm line during its operating history:

- 1974-1979—5 ruptures between Edmonton and the Strome pump station due to manufacturing defects;
- 01 September 1989—rupture at MP 549.5 due to corrosion fatigue;
- 17 October 1990—leak at MP 722.8 due to sulphide stress cracking;
- 16 June 1995—rupture at MP 518.87 due to narrow, axial, external corrosion (NAEC) under disbonded coating (TSB report No. P95H0023);

- 13 November 1995—rupture at MP 548.86 due to fatigue cracking under disbonded coating (TSB report No. P95H0047);
- 27 February 1996—rupture at MP 506.68 due to NAEC under disbonded coating (TSB report No. P96H0008); and
- 20 May 1999—rupture at MP 444.18 due to corrosion fatigue under disbonded coating (TSB report No. P99H0021).
