Two-Part Epoxy Deemed Best For Pipeline at Saltwater Channel

By **John Strong**, Technical Field Specialist, Pipeline Products Division, **Polyguard Products**

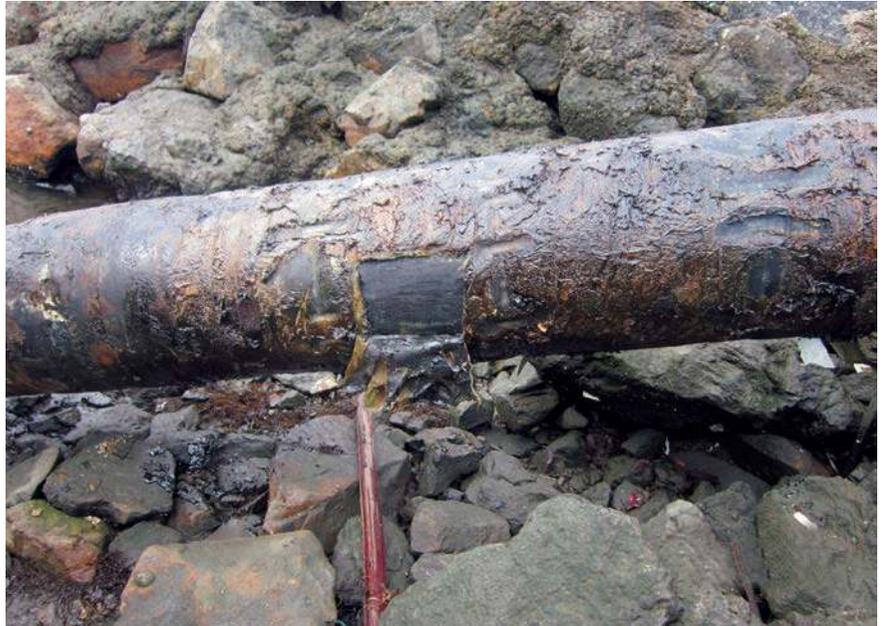
Figure 1

Time and the environment had caused the somastic coating to fail and crack along most of the tidal region of the pipeline. In the past, repairs on the coating had been conducted using soft petroleum-based wraps with an associated primer (**Figure 1**). The wraps were then encased in a thick high-density polyethylene (HDPE) shield to prevent floating debris from damaging the soft coating.

The thick plastic wrap also shielded the pipeline from cathodic protection current when the tide would rise to its installation level. While the cathodic protection would no longer protect the pipeline from corrosion, the soft petroleum-based wrap was also leeching into the channel during every tidal event.

These petroleum-based wraps need to be sealed to prevent leeching into the soil or water. The seal most likely would also have shielded cathodic protection current but it would have kept the primer from leeching into the channel. Eventually, after enough tidal events, the petroleum-based wrap would act as a sponge for the saltwater.

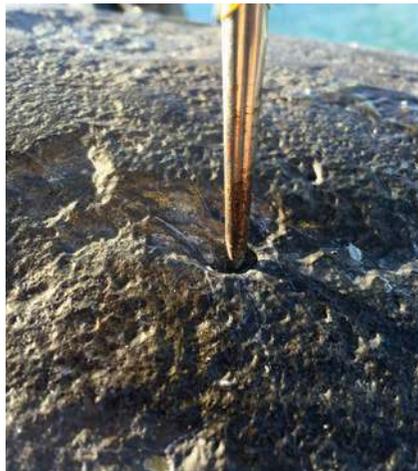
Figure 2

As the tide rose, it would get wet. As it fell, it would hold the saltwater against the pipe surface where no cathodic protection could protect it due to the pipe being above the surface (**Figure 2**).

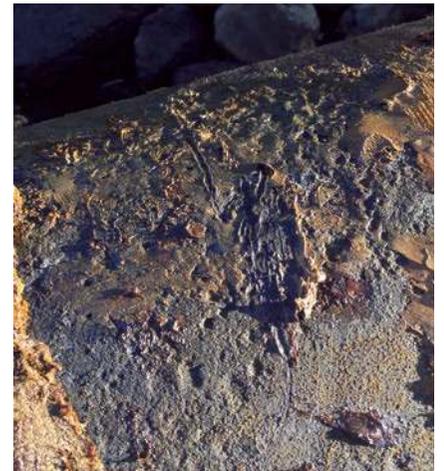
Figure 3

The initial integrity assessment by the operator required sleeving the pipelines for the entirety of the tidal range. Anomalies were found that required immediate repairs, and most of the extensive damage was

under the coating that received the wet-dry cycling (**Figure 3**).
