# FAMILIARISING the *unfamiliar*

**Luc Perrad,  
Polyguard  
Products, Belgium,**  
discusses how a non-  
shielding coating is being  
introduced into the European  
and African pipeline markets.

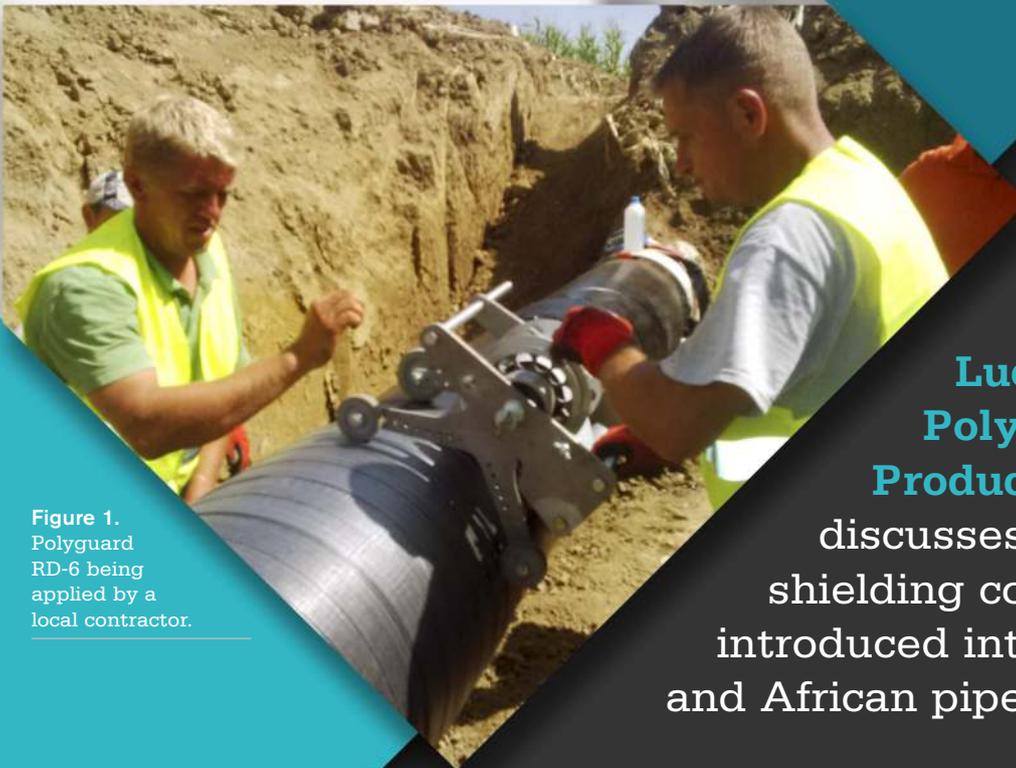
Figure 1.  
Polyguard  
RD-6 being  
applied by a  
local contractor.

pipeline coating to address the problem of cathodic protection (CP) shielding and is a wrapping material that comprises a continuous layer of cold-flowable rubberised bitumen, bonded to a non-elastic polypropylene mesh backing.

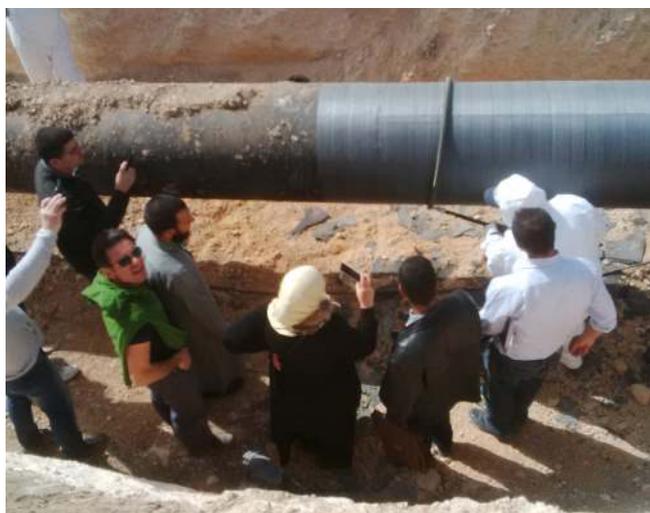
Figure 2. Holiday detection at 10 kV.

- Holiday detection at 10 kV: no holiday.
- Thickness test: 1.2 mm on single layer and 2.3 mm on double layer.
- Adhesion test: 5.6 N/mm.

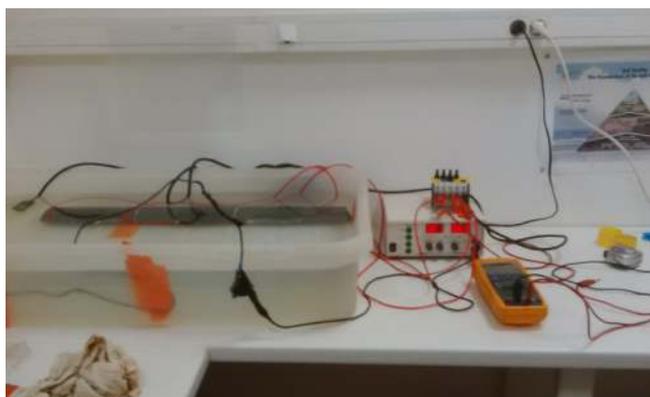
Figure 3. General overview of the testing in Ingeca's laboratory.

To demonstrate to pipelines operators that its RD-6 coating does not shield CP current, Polyguard conducted laboratory tests with Ingeca. Stated below is the test method and the results of the testing.

In October 2015, three 30 x 40 mm steel coupons were installed on a PVC pipe and coated using RD-6. An overlap area was left just above each coupon. Coupons 1 and 2 had been coated with intentional RD-6 disbondment, leaving a void filled with water between the coupon and the coating. Coupon 3 was properly coated without void between the coupon and the coating.

Contrex commercial water with following salt composition was injected under the disbanded RD-6 coating: Ca: 468 mg/l; Mg: 74.5 mg/l; Na: 9.4 mg/l; SO: 1121 mg/l; HCO: 372 mg/l. The PVC pipe was immersed in the same commercial water and no additional salt was added.

Two additional non-coated steel markers were used. One marker was in the same electrolyte and container as the three

coated coupons (same CP protection), while the other was in the same electrolyte but in a different container from the three coated coupons (no CP protection).

Tests were conducted for three months. After this period and once the RD-6 coating had been removed, no corrosion was observed on coupons 1, 2 or 3.

The original pH of the electrolyte (commercial water) was 7. The uncoated marker with CP was covered by calcareous sediment after chemical reaction due to CP current. The pH tested on the surface of the sediment was 12. Under the disbanded RD-6 coating on coupons 1 and 2, pH 12 was also measured. The uncoated marker without CP was covered in rust. The pH levels on the surface of the rust was between 6 and 7. Finally, since there was no water under coupon 3, no pH was measured on this coupon.

The tests were convincing. A presence of current was measured on each coupon, visual inspection after three months showed no corrosion under any of the coupons and pH 12 was measured under disbanded RD-6. Thus, it can be drawn that a polymeric mesh backed coating, such as Polyguard's RD-6, does not shield CP current.

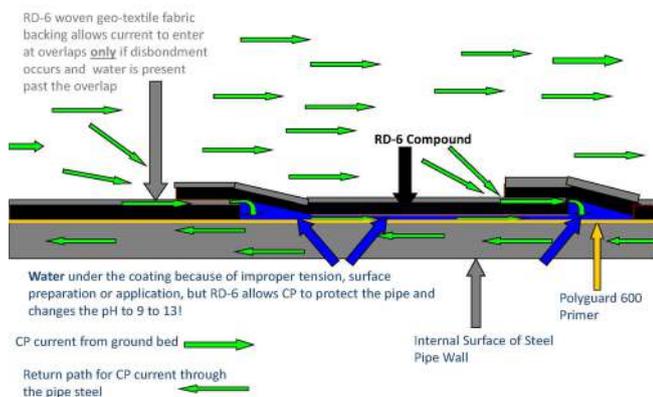
Figure 4. CP current (green arrows) can reach through the overlap under disbonded RD-6.

In North America, there is concern regarding cathodic shielding problems. Standards, such as NACE SPO 169-2007 and the US Code Federal of Regulation's 49 CFR 192.461, 195.551 and 192.112, prohibit the use of shielding coatings. Moreover, many pipeline operators have complained about pitting corrosion due to the use of shielding coatings. However, the non-shielding property of RD-6 is illustrated in Figure 4.

Its woven geotextile fabric (mesh) backing is conductive and allows CP current to enter under the disbanded coating at overlap areas. This can only happen if disbondment occurs with water present past the overlap.
