Changing paths in Latin America

Ana Cervantes, Polyguard, USA, describes how some companies in Latin America are changing the way they approach rehabilitation and field joint coatings.

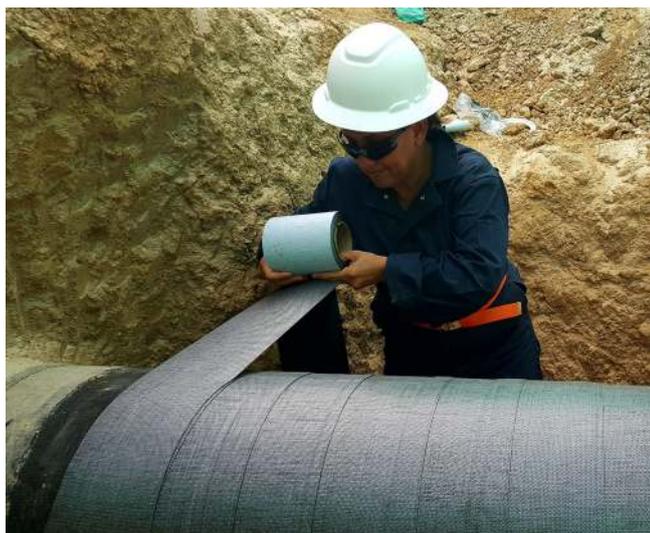
Figure 1. Installing RD-6 on a pipeline.

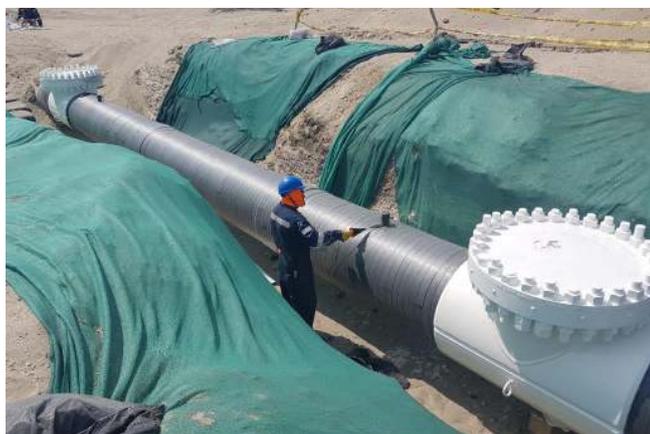
Figure 2. RD-6 applied in Peru.
