RG-2401[®] DATA SHEET & INSTALLATION

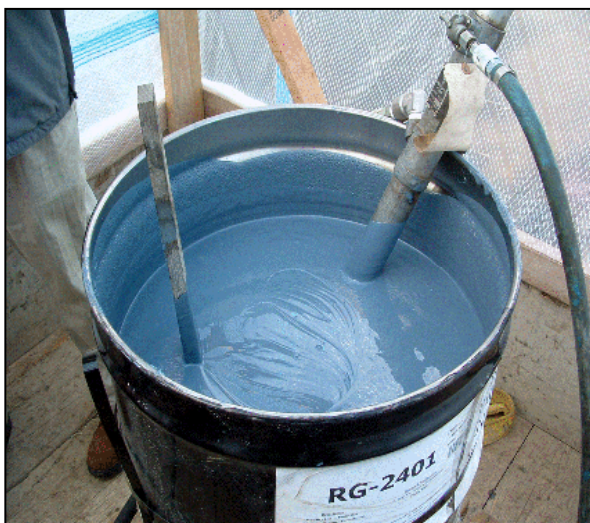
Application is made using common transfer pumping equipment (see photo below left).

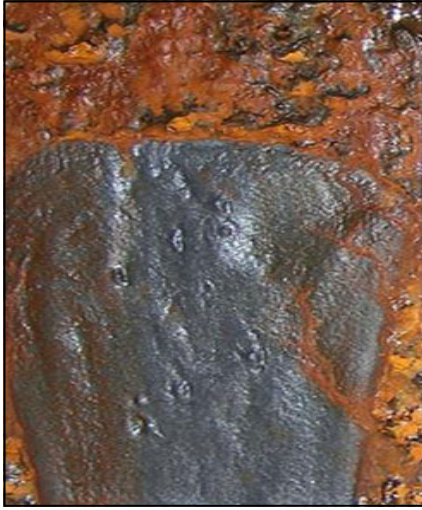
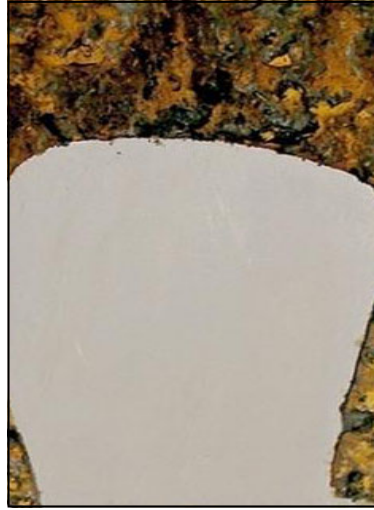
ASTM B-117 Salt fog testing was done to demonstrate **RG-2401's** corrosion stopping ability. The gel was applied to a blasted steel panel and subjected to 2000 hours in the salt fog test. When removed from the test (*left photo*) corrosion rates were aggressive. After cleaning the panel (*right photo*) the metal was as "shiny new" as before testing. Note the defined edges - **NO UNDERCUTTING**.
