**FINAL REPORT**  
**R335-01**

**INVESTIGATION OF THE SHIELDING BEHAVIOR  
OF TWO PIPELINE COATING SYSTEMS**

**POLYGUARD PRODUCTS, INC.**  
ENNIS, TEXAS

**MARCH 2001**

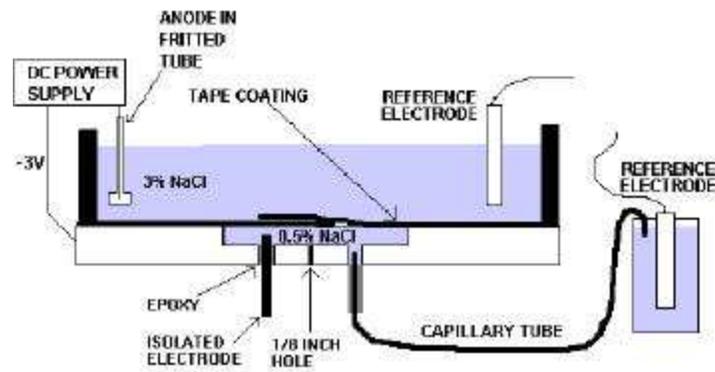
Figure 1. A schematic of the setup used for each of the 4 cells.

Four different test cells were set using the supplied test cells, Polyguard 600 primer, and the two different coatings (RD-6 and 610). A cut-away diagram of the setup is shown in Figure 1. A photo of the basic cell setup is shown in Figure 2.

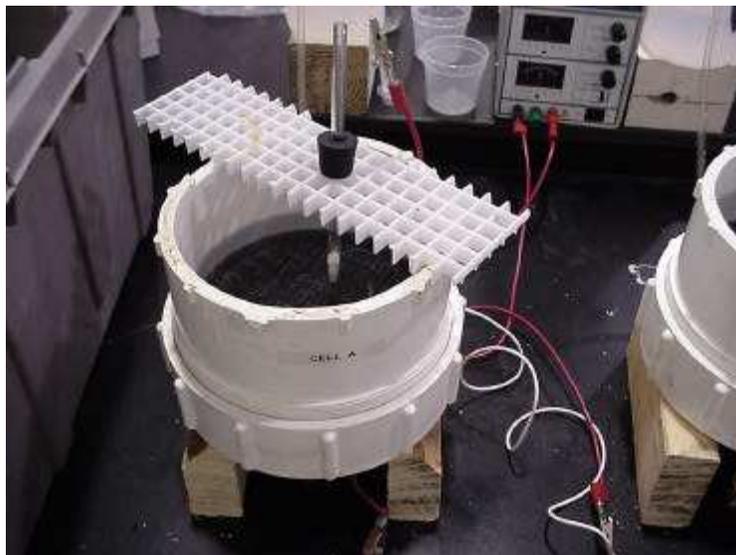
Figure 2. The setup of Task 1 showing Cell A attached to a power supply. And this is how it will look for 2 or more lines of a detailed caption.

Cell A consisted of RD-6 coating system with no existing lap joint over the void. Also, the primer was not applied to the area within the void. (Does CP pass directly through the tape?)

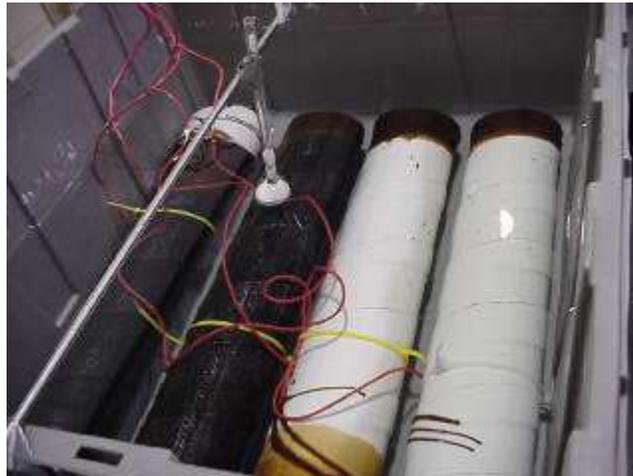
Figure 3. The four 18-inch long, 3 inch diameter pipes coated in either RD-6 or 610 coatings and submerged in 3% NaCl solution for Task 2.

1. Each of the four 18-inch long, 3-inch diameter carbon steel pipes had 4 grooves (~1/8" deep) machined into them using a Dremel tool.
2. The pipes were abrasive blasted with black beauty abrasive medium to obtain a near white finish with an anchor profile of 2 to 4 mils.
3. An insulated copper lead wire was cad-welded onto each of the pipes.
4. The pipes were de-greased using methanol.
5. Two of the four pipes were primed using the supplied Polyguard 600 primer. Primer was not allowed to coat the inside of the machined grooves.

A photograph of the setup for Task 2 can be seen in Figure 3.

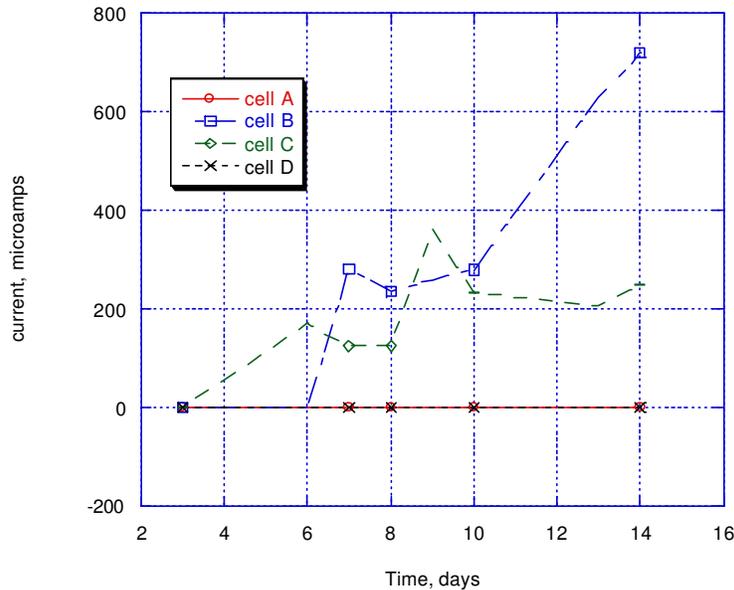
Figure 4. Current readings as a function of time through different tape joints.

A plot of the amount of current evidenced is shown in Figure 4.

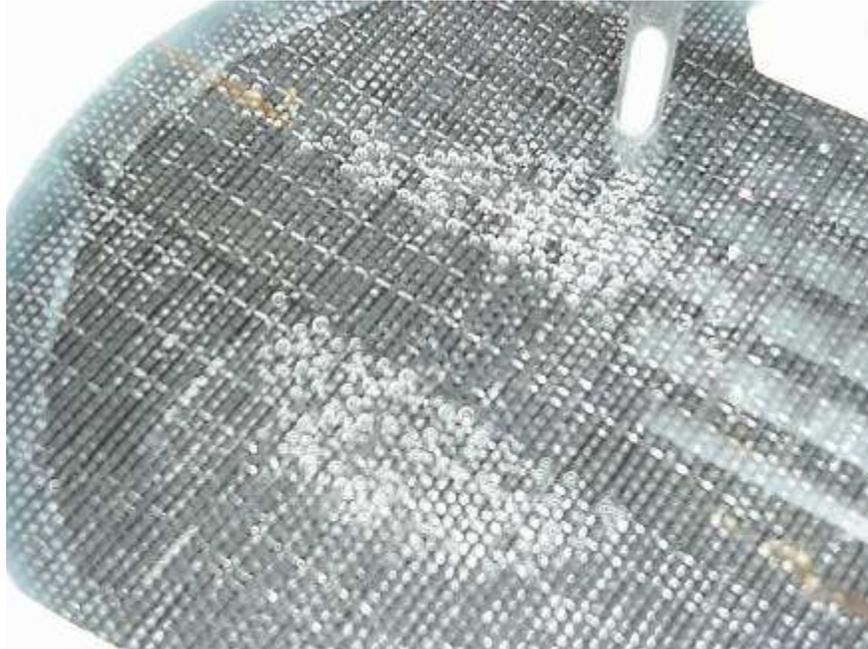
Figure 5. Bubbles framing the lap joint region over the void in Cell B.

Bubbles appeared on the surface of the tape in Cell B, which did not have the void primed and was coated with RD-6 system (see Figure 5). Presumably this was hydrogen outgassing due to the cathodic reaction at the surface. The combination of high surface area of the unprimed void and the successful application of CP to this void resulted in the excessive amount of hydrogen production which was evidenced. In the sample where the void was primed, the smaller surface area for the cathodic reaction on the steel resulted in less hydrogen being produced, thus bubbles were not evident.

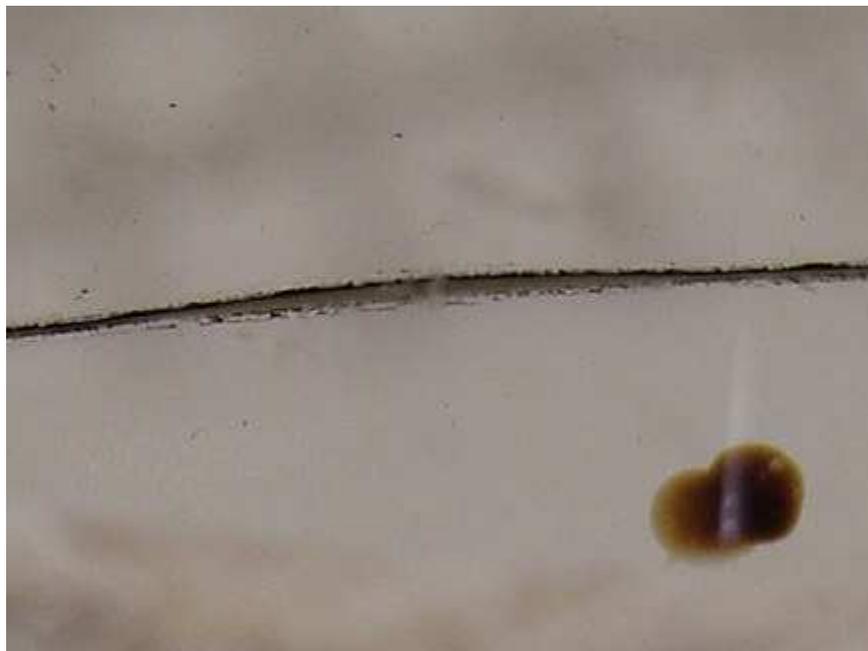
Figure 6. The lap joint in Cell D coated with 610 tape, showing partial joint separation.

The lap joint in the 610 tape (Task 1 activity only) began to separate late in the test (see Figure 6). Since the coating application over the flat test specimen did not allow for the proper spiral tension, as would be present if the coating were properly wrapped around a pipe, more pressure or weight for a longer period of time may have been required to provide a better seal. However, this did not appear to cause any leakage when the data from Table 1d is examined.
